DVASE 2018 Excellence in Structural Engineering Awards Program

Approximate construction cost of facility submitted:	\$2.5M
Name of Project:	American College of Physicians - Parking Structure Repair
Location of Project:	Philadelphia, PA
Date construction was completed (M/Y):	May, 2018
Structural Design Firm:	CVM Engineers
Affiliation:	All entries must be submitted by DVASE member firms or members.
Architect:	None
General Contractor:	Pullman SST - Swedesboro, NJ

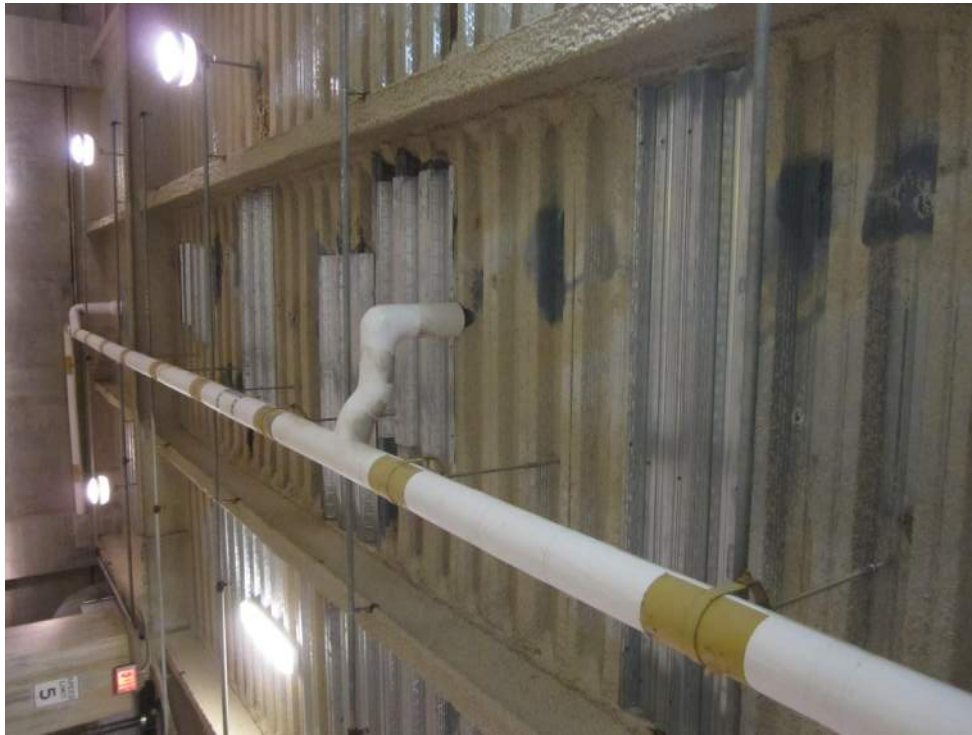
Figure 1. Supplemental decking added to supplement metal deck that corroded through.

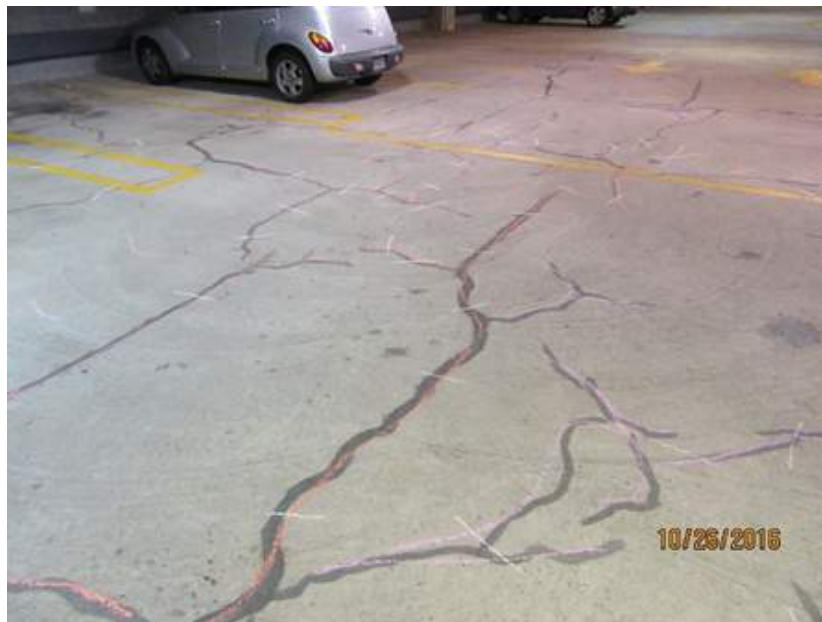
Figure 2. Extensive cracking on parking deck surface.

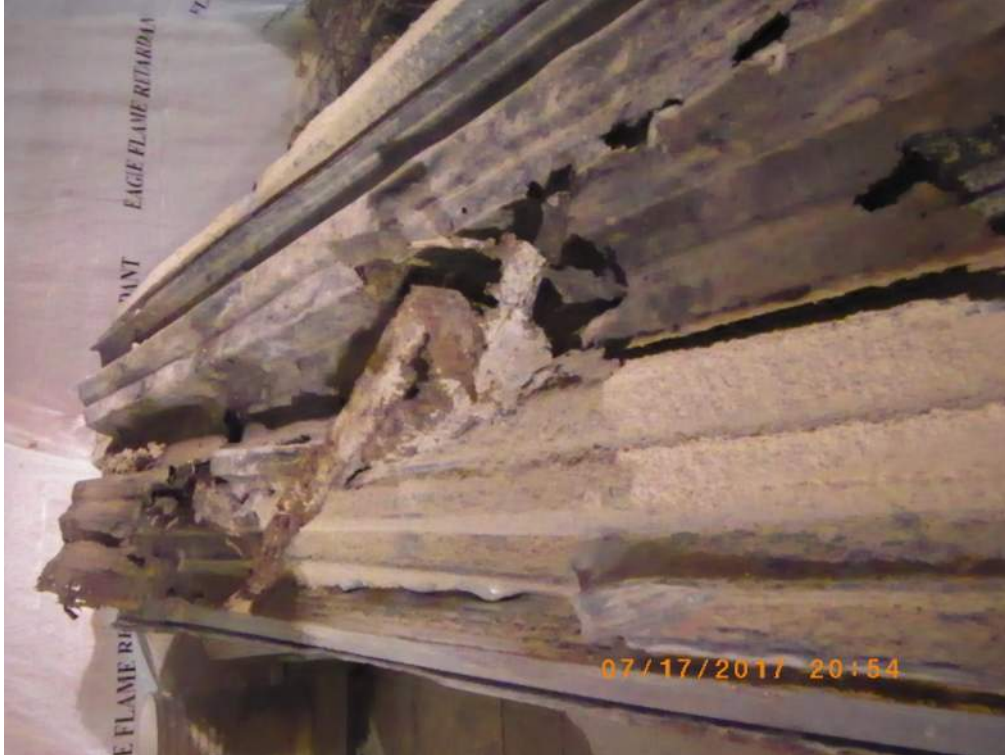
Figure 3. Corrosion damaged metal deck after removal of concrete.

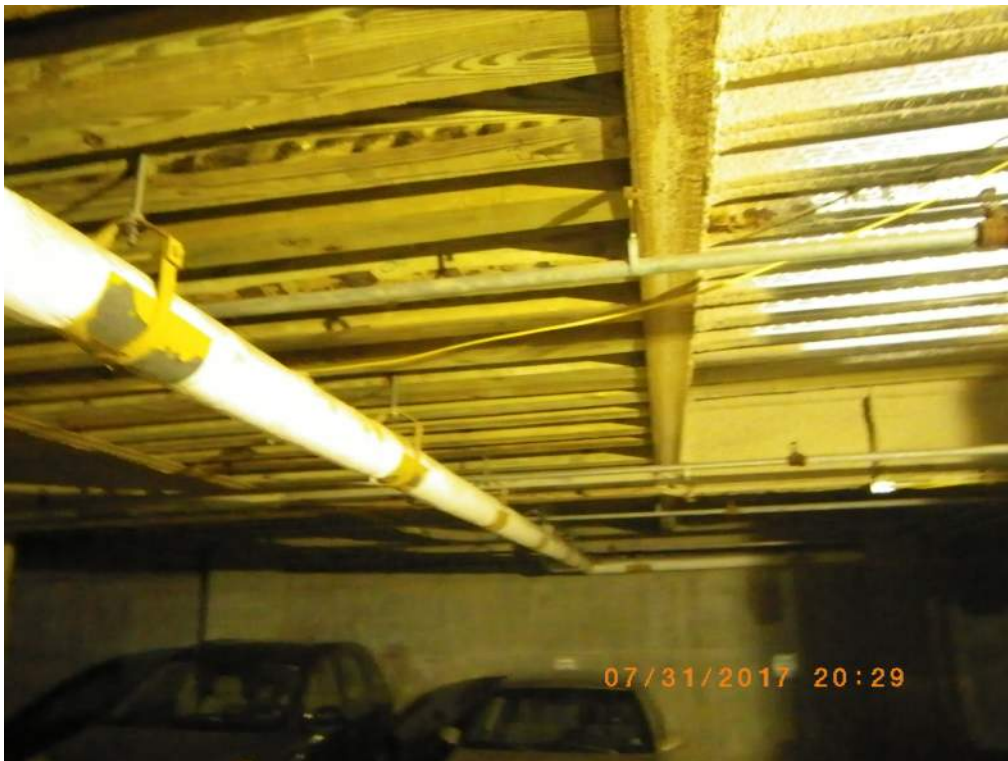
Figure 4. Supplemental shoring / work area support.

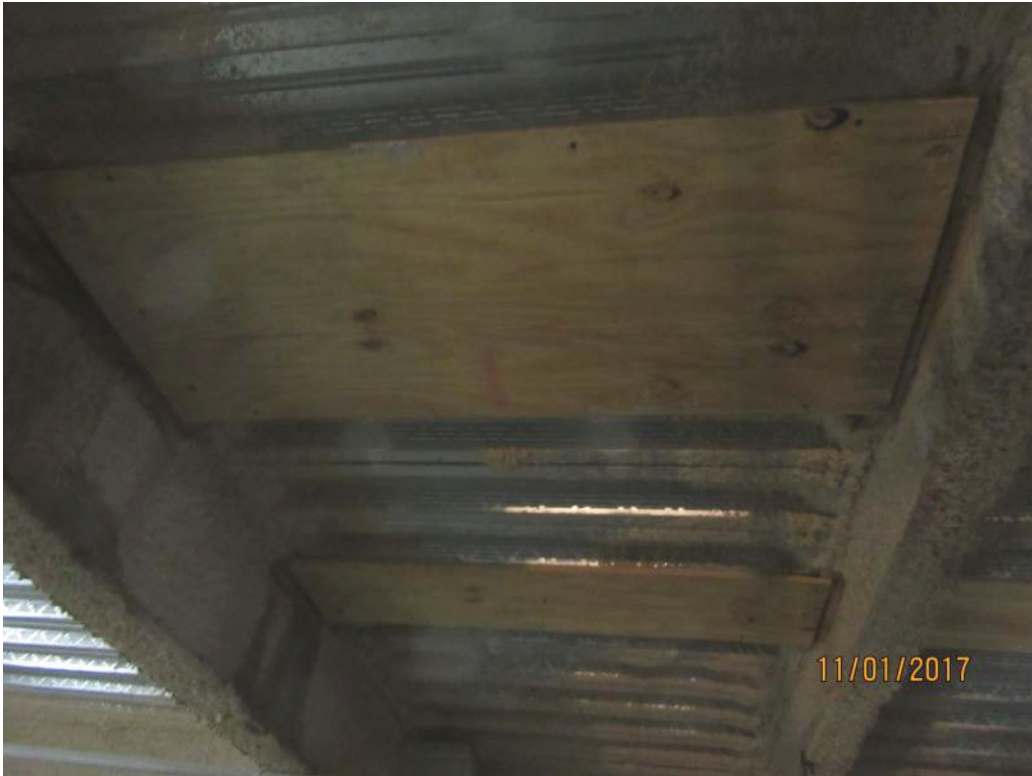
Figure 5. Formwork for isolated full-depth repairs.

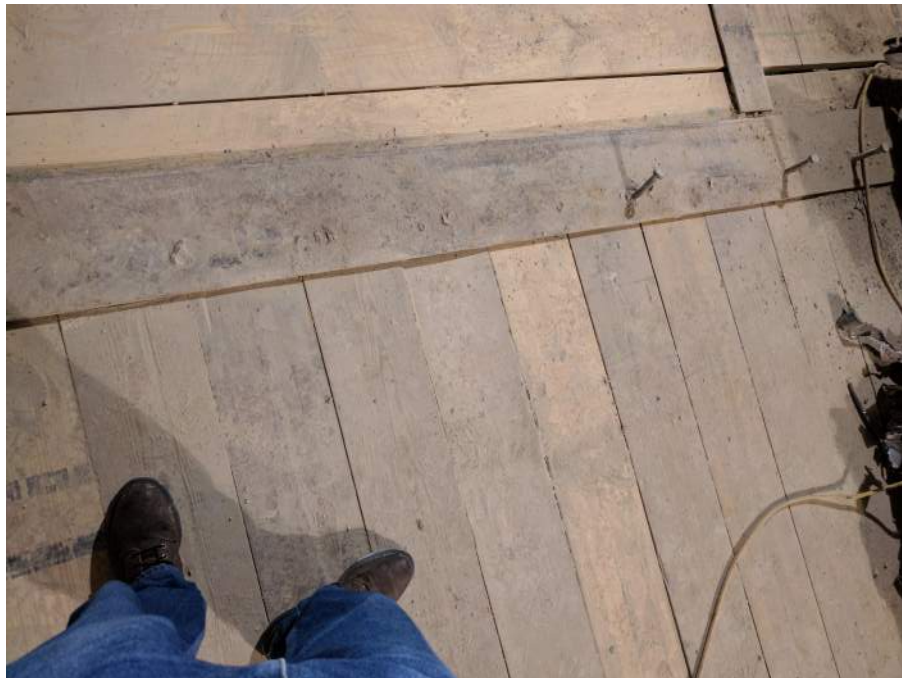
Figure 6. Formwork in progress (note missing shear studs).

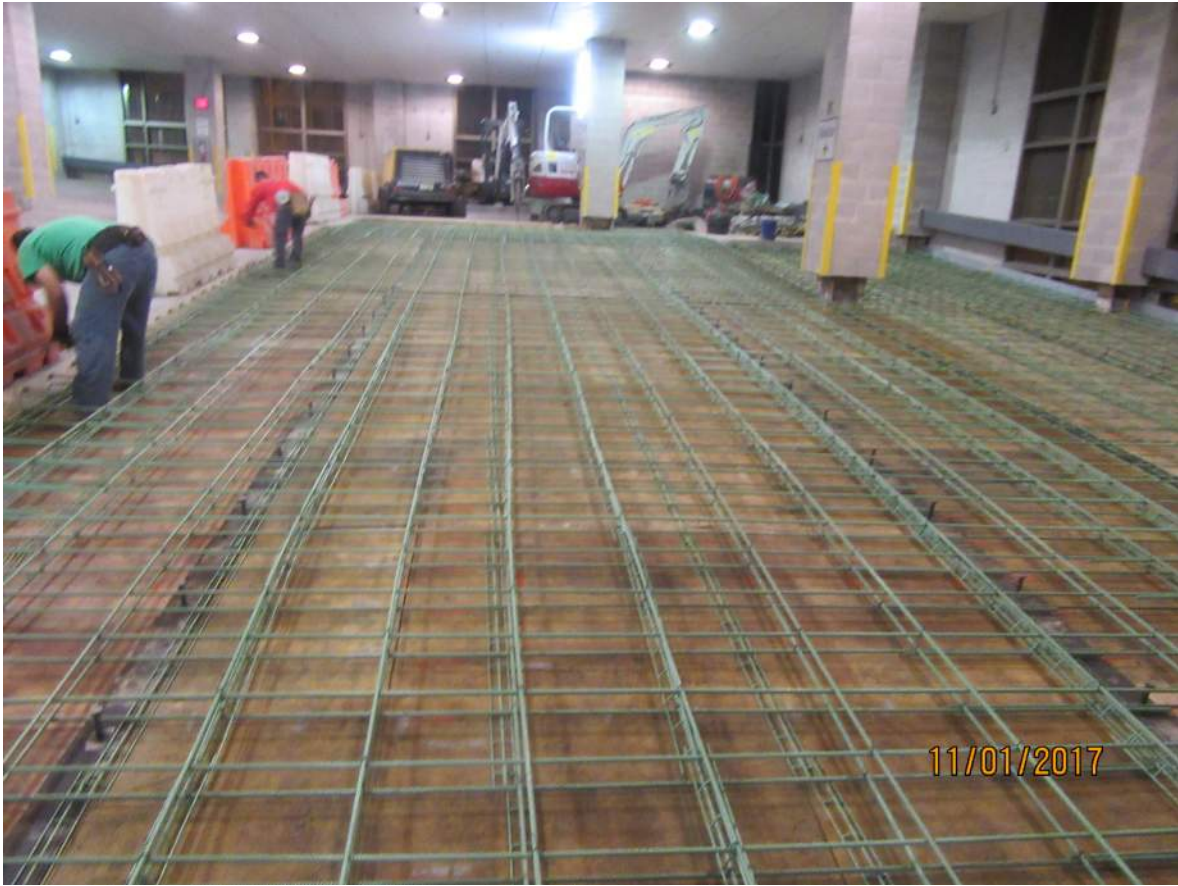
Figure 8. Deck reinforcement in place prior to concrete placement.

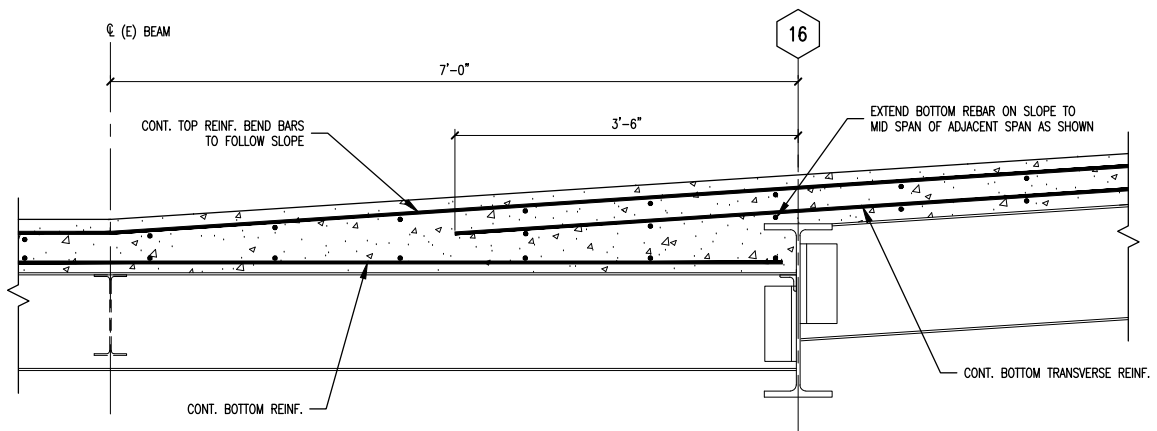
Figure 9. Repair detail at sloped ramp.
