## DVASE 2010 Excellence in Structural Engineering Awards Program

Approximate construction cost of facility submitted:	\$52 Million
Entry Fee:	<b>FREE</b>
Name of Project:	The Salvation Army Ray and Joan Kroc Corps Community Center
Location of Project:	Philadelphia, Pennsylvania
Date construction was completed (M/Y):	December 18, 2008 (Construction Documents Issued) October 2011 (Anticipated Date of Construction Completion)
Structural Design Firm:	CVM Engineers
Affiliation:	<b>All entries must be submitted by DVASE member firms or members.</b>
Architect:	MGA Partners– Philadelphia, PA
General Contractor:	TN Ward

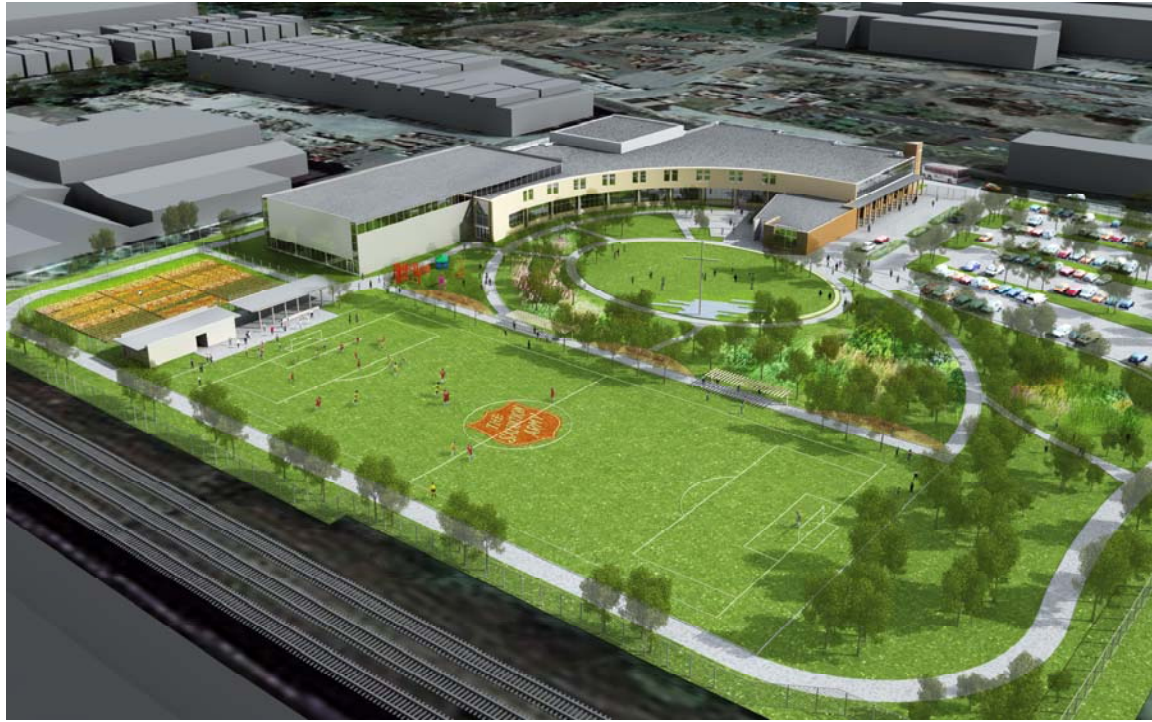
Photo 1:

Arial rendering of the building and site.

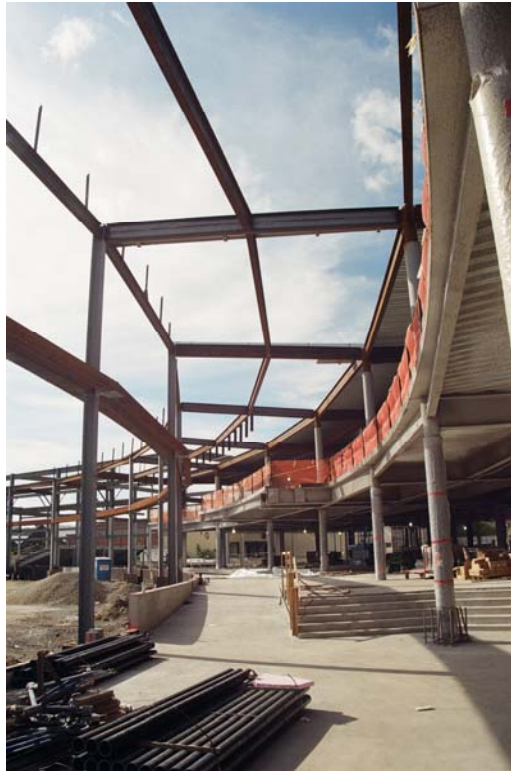
Photo 2:

View of steel framing at two story main lobby.

Other notable aspects of the design of the Kroc Center include the two story main lobby featuring exposed steel columns and expansive use of curtain wall to deliver sweeping views of the site, the east porch and main entrance showcasing exposed steel beams and solid wood decking, and the beacon, a symbolic gesture along Wissahickon Avenue, achieved through the use of a custom fabricated triangular steel column and cantilevered HSS members.

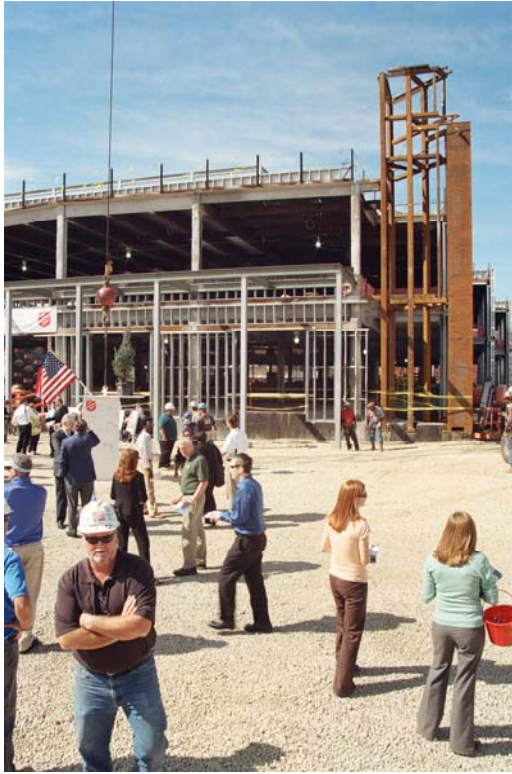
Photo 3:

View of steel framing at the beacon at the northeast corner of the site.

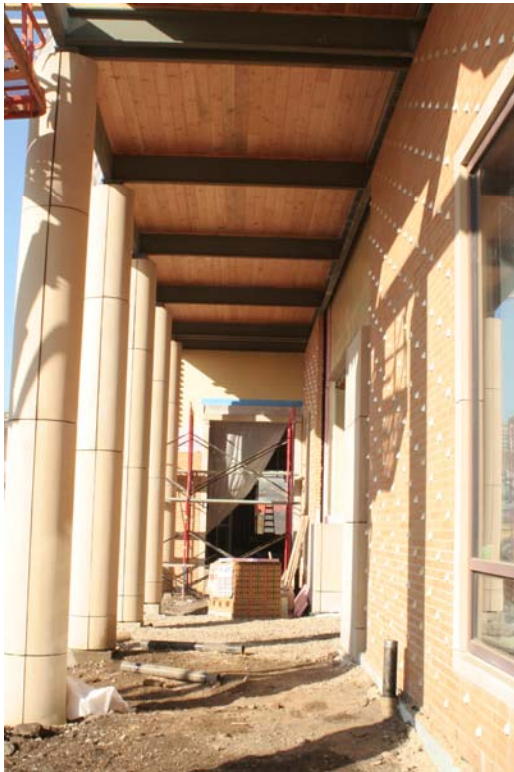
Photo 4:

View of exposed steel and wood decking at the east porch.

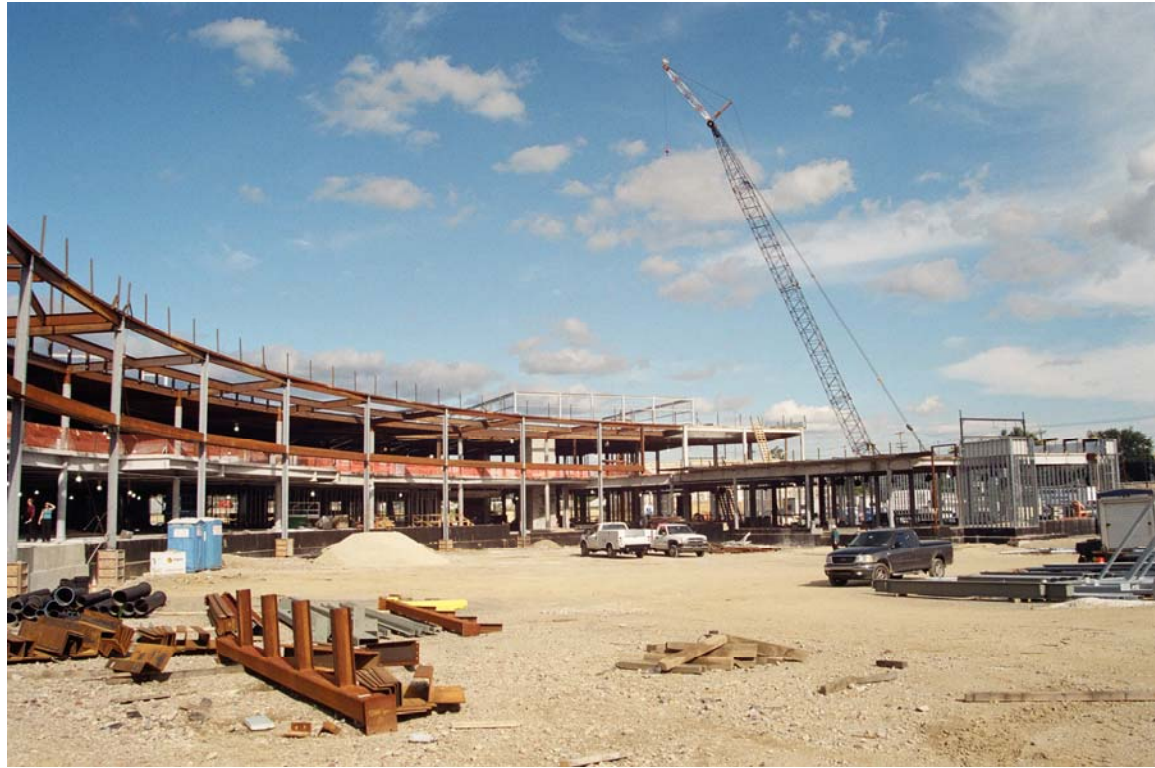
Photo 5:

View of steel framing at the south façade.

The building's façade is a mix of brick, curtain wall, and metal panel, supported by a metal stud back-up system. Multiple, secondary HSS frames were used throughout the building to support these elements.
