DVASE 2020 Excellence in Structural Engineering Awards Program

Approximate construction cost of facility submitted:	~\$4.0M
Name of Project:	Undisclosed International Tech Company
Location of Project:	Cherry Hill, NJ 08002
Date construction was completed (M/Y):	March, 2020
Structural Design Firm:	Orndorf & Associates, Inc.
Affiliation:	All entries must be submitted by DVASE member firms or members.
Architect:	Neumann Smith Architecture
General Contractor:	Wolfe Scott Associates

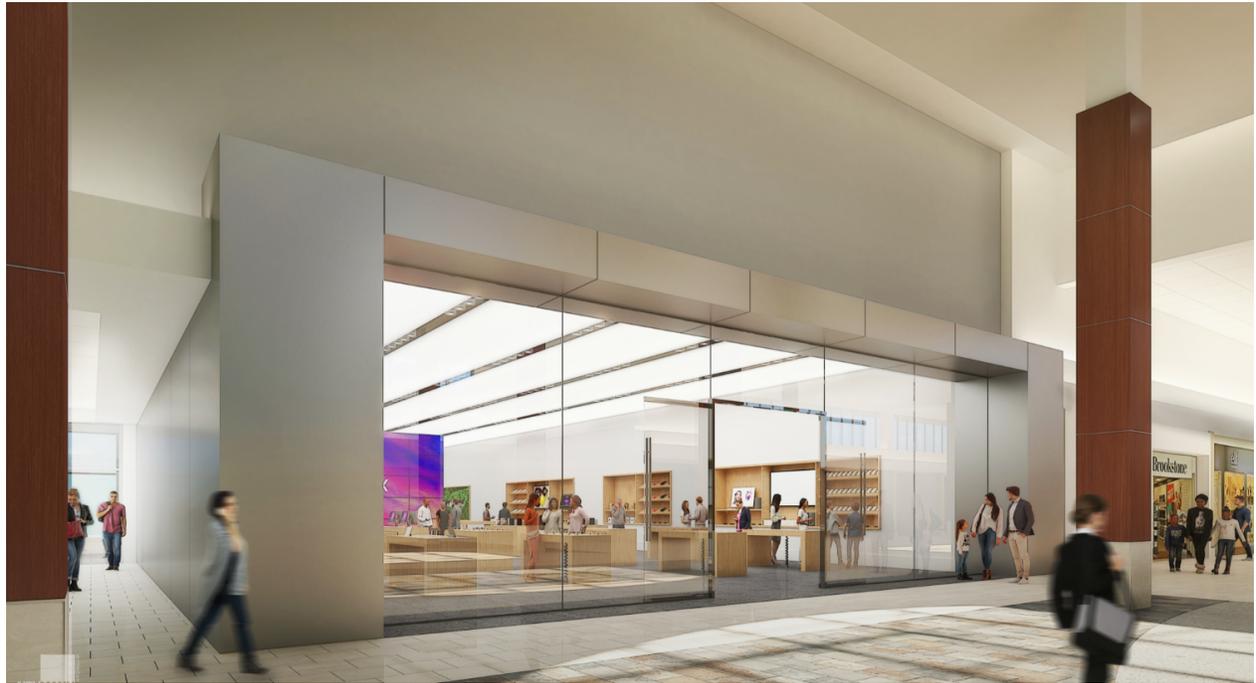
Store Front View (inside Mall)

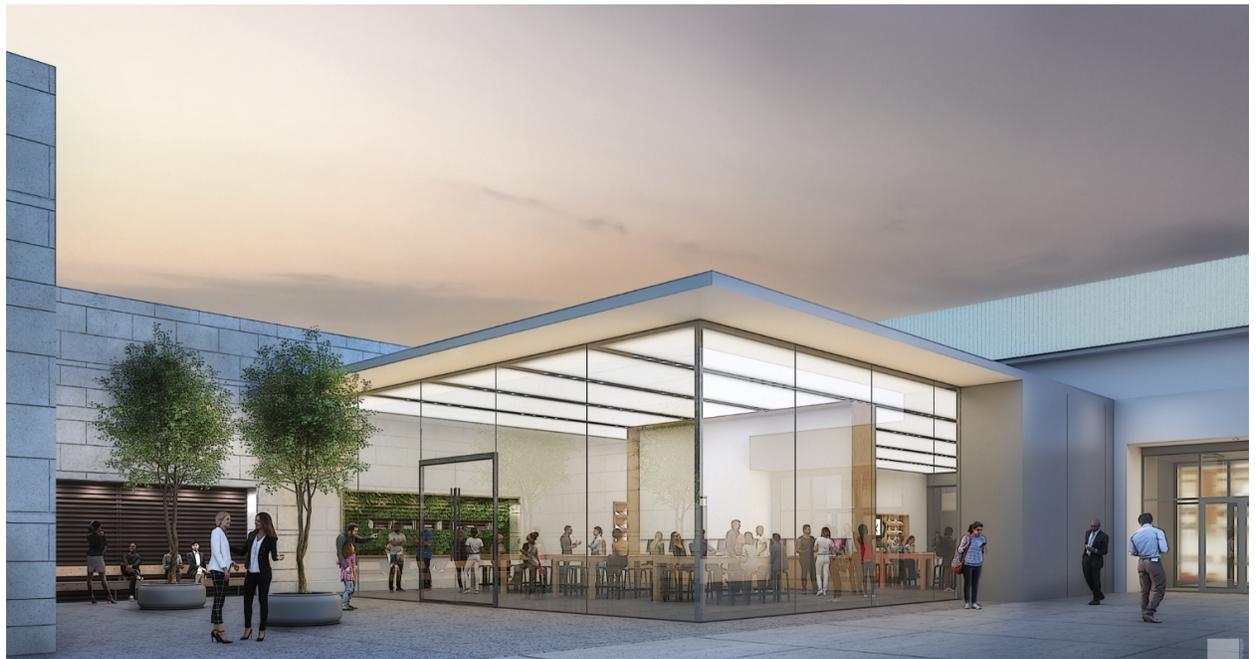
Store Rear View (outside Mall)

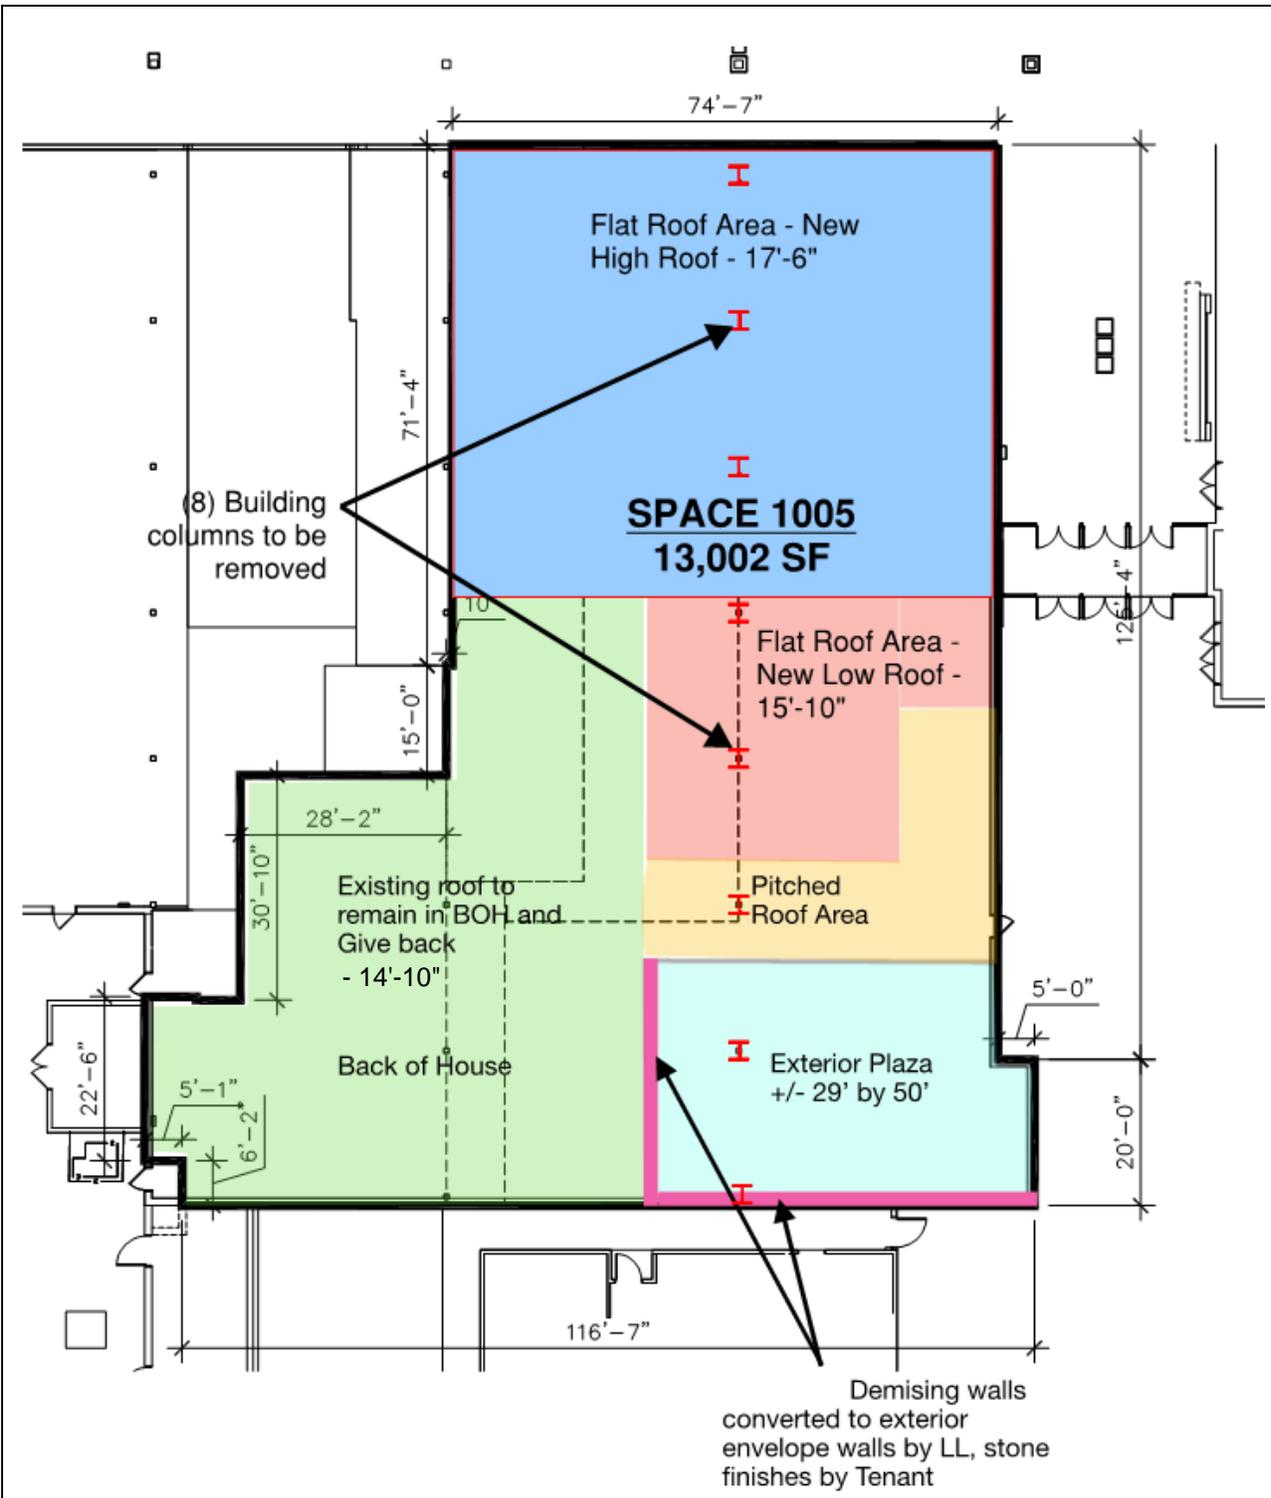
Roof Variation of the Tenant Space

The existing mall roof framing at the tenant spaces are open web steel bar joists (40 ft span) supported by a continuous overhang beam system. The columns are bearing on caisson foundations. By removing eight (8) columns in the middle of the future combined tenant space, the new roof beams needed to span 74 ft and be supported by the existing columns and foundations. The new roof at these areas is raised to two different new and higher elevations. O&A worked with the land lord architect to ensure that the adjacent remain unaffected even when large areas of their common roof framing had to be reconfigured.

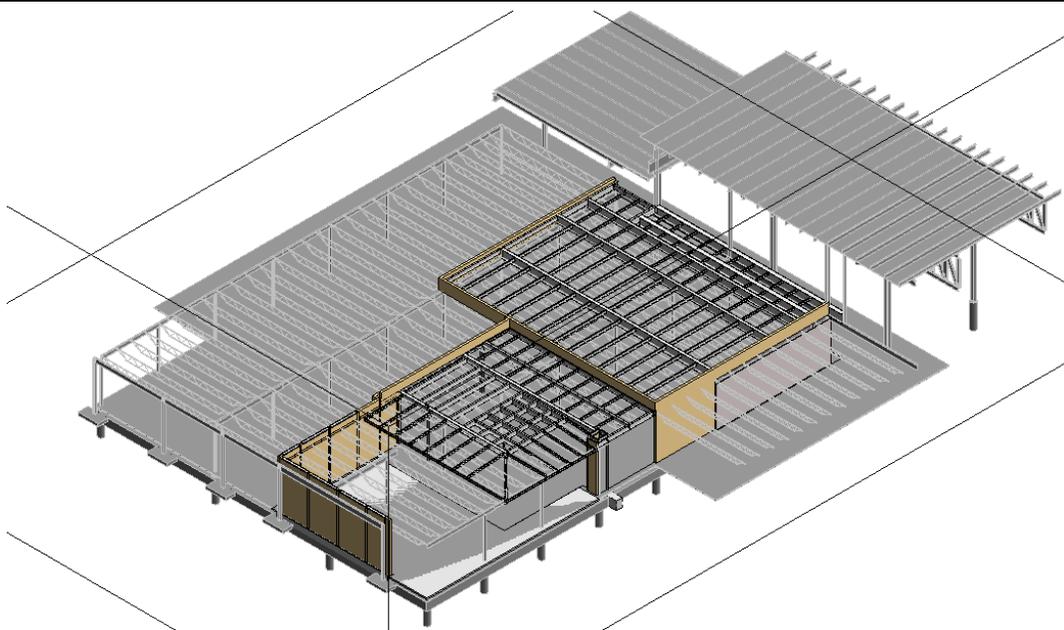
3D Model

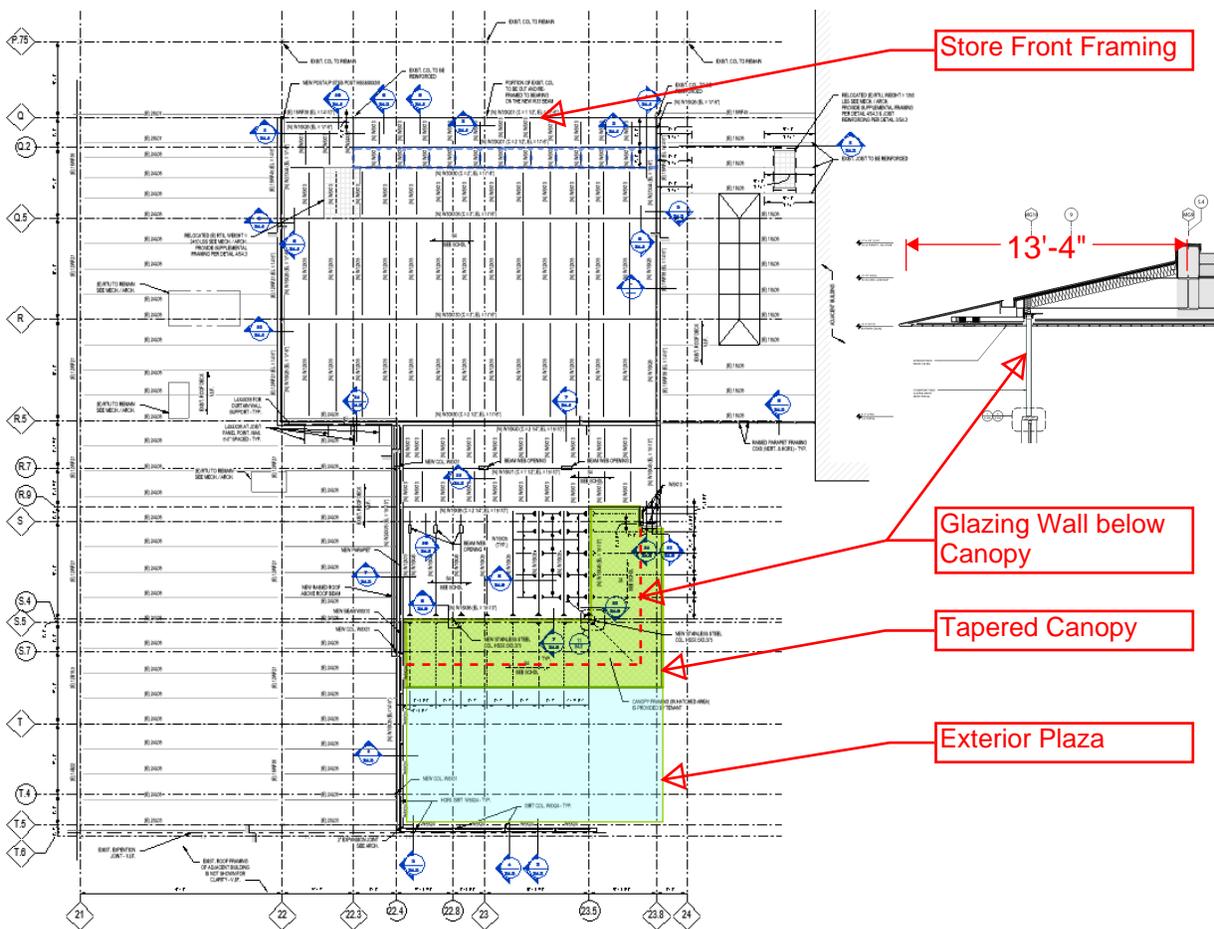
Roof Framing Plan

Store Front Framing

Glazing Wall below Canopy

Tapered Canopy

Exterior Plaza

The 75ft long exterior glazing walls around the corner are pushed out of column line by 8 ft and braced by the 13 ft long tapered canopy at top. The backup steel beam supporting the canopy is designed to limit the deflection of live load to 0.2 inches as well. Special continuous framing connections achieve this minimal deflection and provide a seemingly thin shell canopy that appears to be floating above the exterior glazing. The two round tube columns behind the glazing wall are required to be stainless steel with special finish. The structural design overcomes these challenge by redistributing the loads with proper framing arrangement and beam sizing.

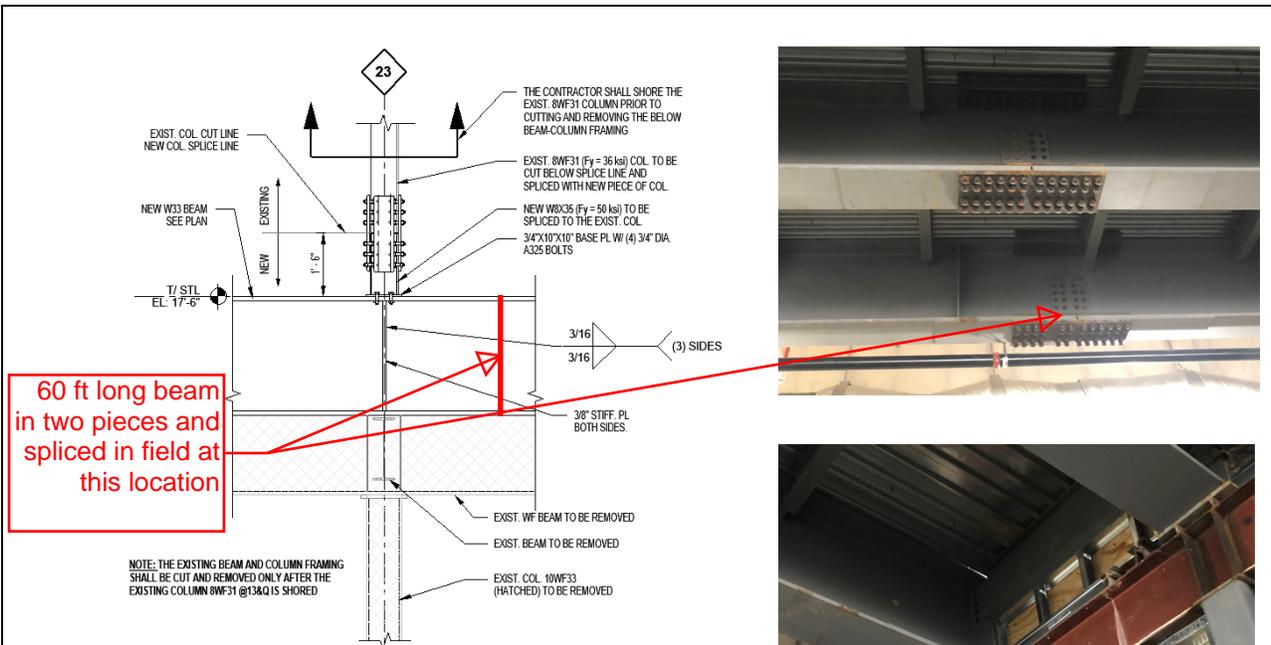
60 ft long beam
in two pieces and
spliced in field at
this location

The third major challenge is the storefront framing. The existing roof beam in the leased space needed to be cut and replaced with a new and deeper roof beam at higher elevation. This 60ft long new roof beam also supports an existing major gravity column for the mall common area high roof; the existing column's lower portion was cut and removed. The long span beams have to be brought in by two pieces and spliced in field. The contractor was instructed to pre-load the storefront beam to account for the deflection caused by the post-up high mall. In fact due to the non-existing ceiling cavity (ceiling is at bottom of structure), and intended ceiling architectural design, limiting deflections for long spans was one of the biggest challenges of the job. Special steel design and detailing of the beam web openings was also required as the special wood left no space for HVAC ducts. The west end of the storefront beam continues over an existing column to pick up the load from another existing high roof post-up column on the existing beam. The restrict requirements from the tenant design put a lot of challenge on the structural design. The 60ft long storefront beam was required to limit the live load deflection to 0.2 inches! Six (6) pivot doors are installed to the 50ft long door opening at the storefront, which required special attention to the bracing elements.

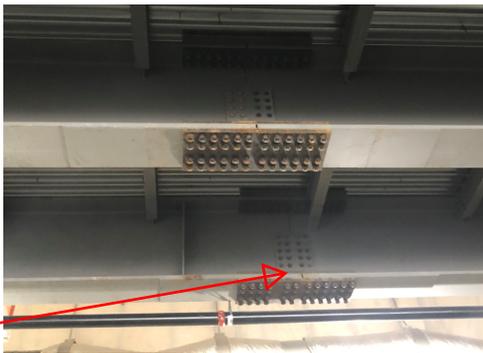
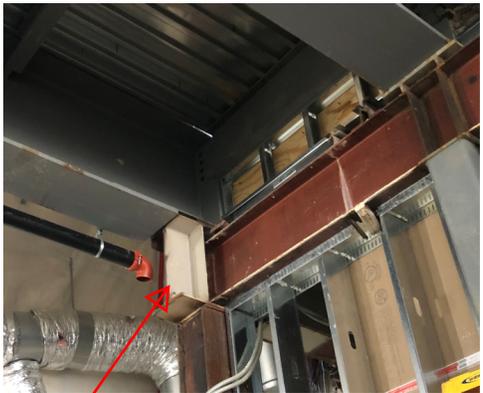
2 NEW BEAM TO SUPPORT EXIST. COL. AT LINE Q
S4.1 1/2" = 1'-0"

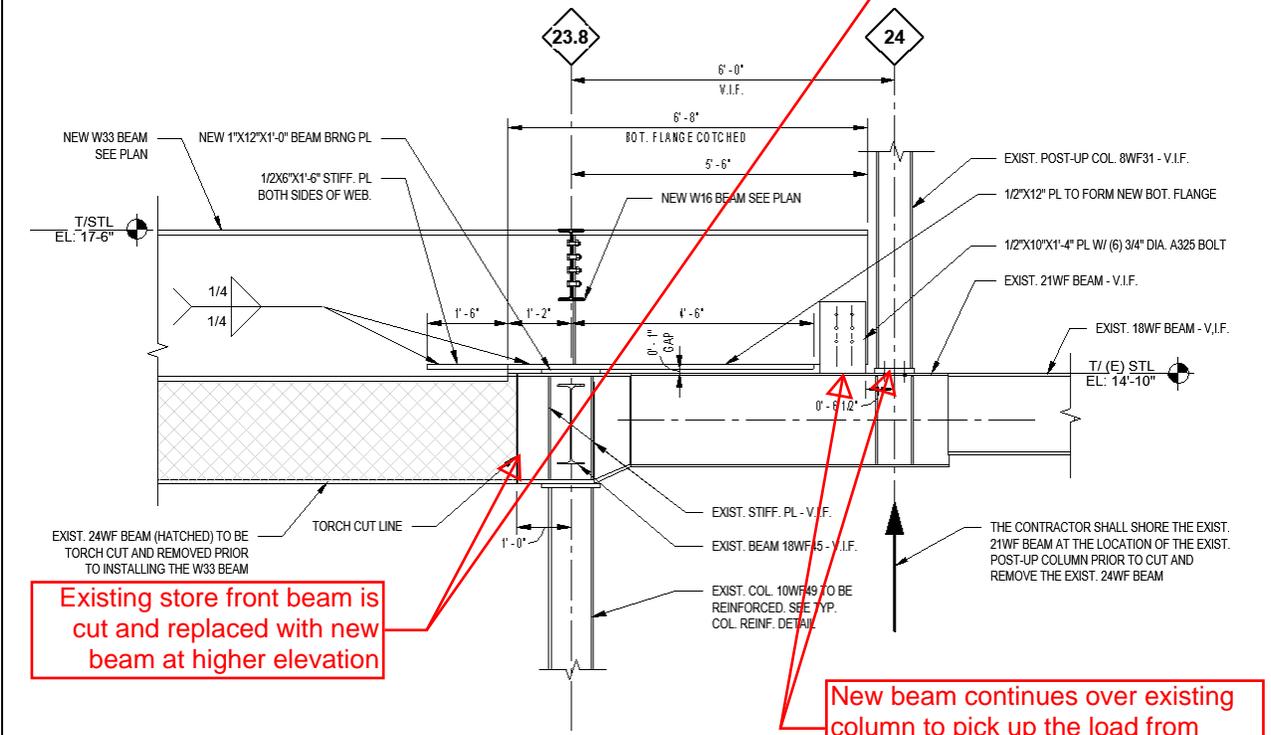
Existing store front beam is
cut and replaced with new
beam at higher elevation

New beam continues over existing
column to pick up the load from
existing post-up column

3 BEAM CONNECTION ALONG LINE Q
S4.1 1/2" = 1'-0"

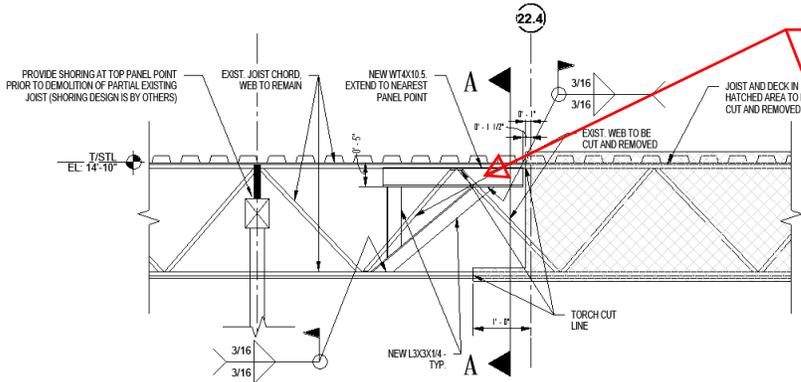
Existing joist is cut and new bearing seat is formed

SECTION A-A

DETAIL OF EXIST. JOIST DEMO / NEW SEAT FORMING BTWN LINE R.5 AND S.7

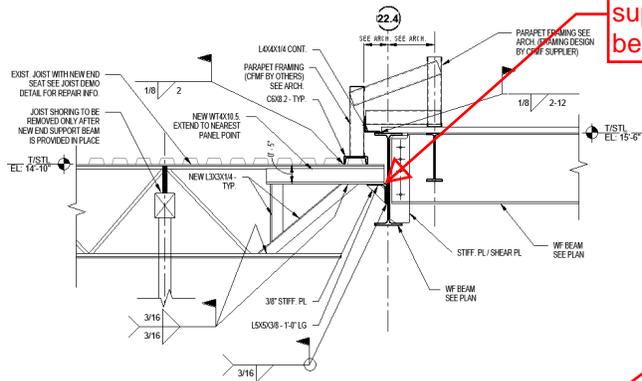
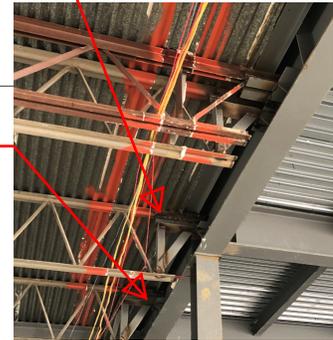
Existing joist is cut and supported by new roof beam

SECTION THRU NEW TO EXIST. ROOF

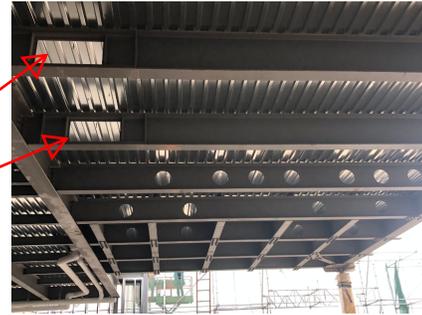
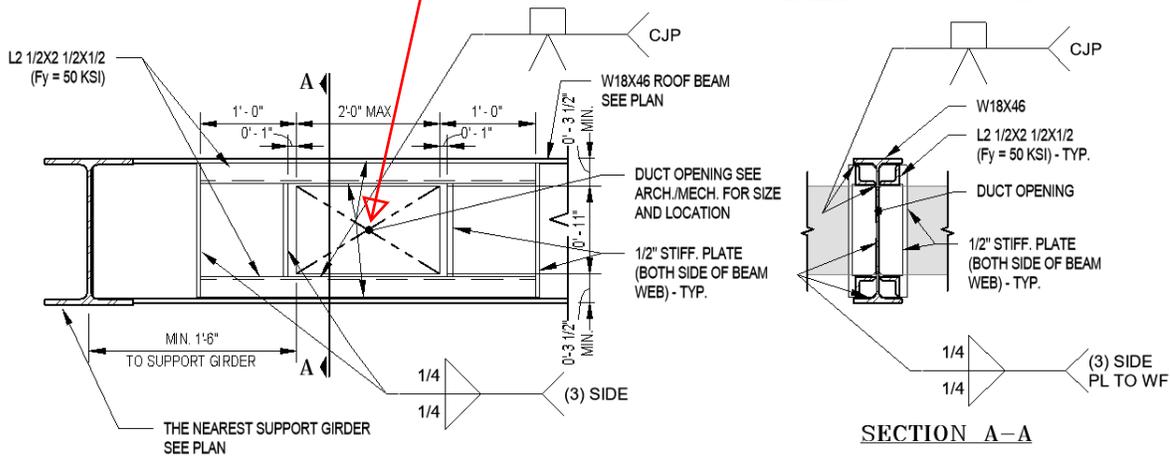
Beam web opening for duct work

SECTION A-A

BEAM WEB OPENING DETAIL
