DVASE 2022 Excellence in Structural Engineering Awards Program

Approximate construction cost of facility submitted:	\$65 Million
Name of Project:	Harvard University Adams House - Phase 1 - Claverly and Senior House
Location of Project:	Cambridge, Massachusetts
Date construction was completed (M/Y):	March 2021
Structural Design Firm:	CVM Engineers
Affiliation:	All entries must be submitted by DVASE member firms or members.
Architect:	Beyer Blinder Belle Architects and Planners
General Contractor:	Lee Kennedy Co. Inc.

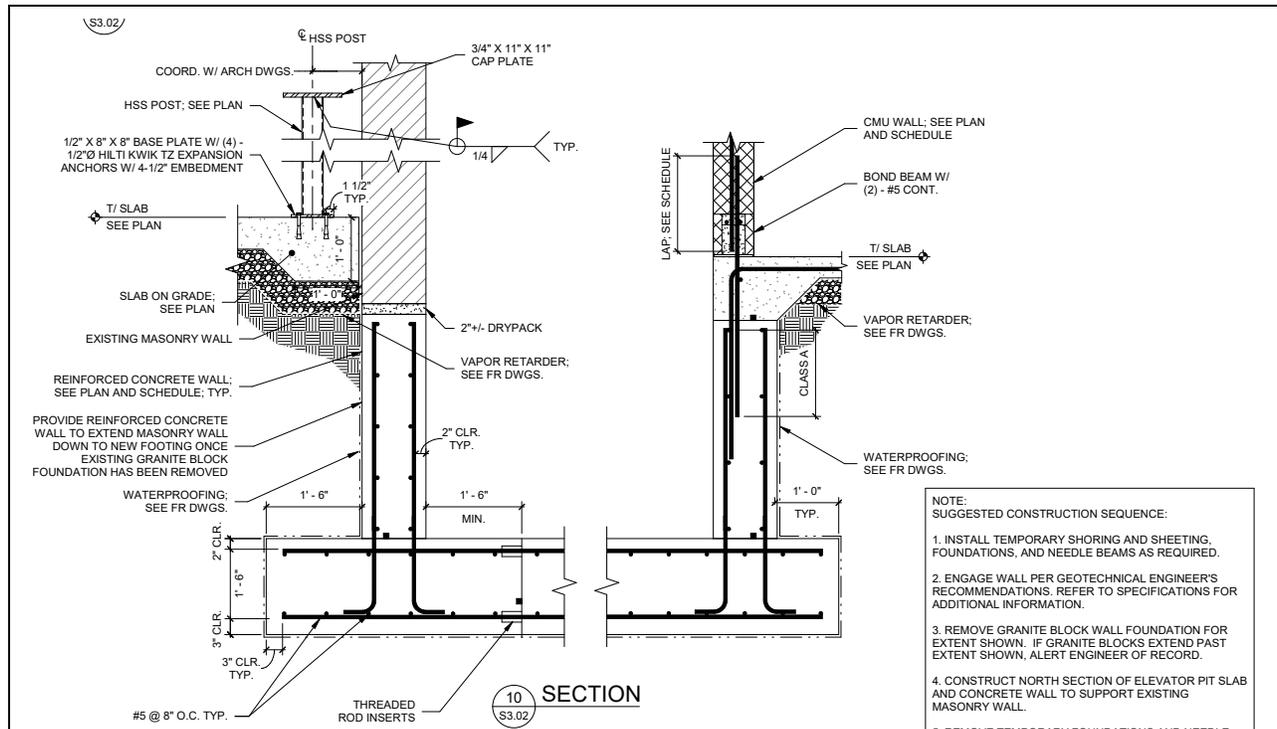
Figure 2 - New work section through the existing masonry wall where the granite block foundations were removed. The foundation was poured in two sections to help act as shoring under the existing masonry wall, so that the needle beam shoring could be removed prior to finalizing the pit.

During exploratory surveys, it was found that the granite block foundation extended 18" from the brick wall in the location of one of the new elevators. The area surrounding the elevator was very tight from an architectural standpoint and shifting the elevator away from the masonry wall by 18" was not an option. Not only was there an issue with the width of the granite foundation, but it was also discovered that the foundations under the interior masonry walls did not extend farther than 18" below the crawl space slab. Both of these issues ultimately lead to the decision to shore the existing masonry wall and remove the granite block foundations in the area of the new elevator pit.

CVM worked closely with the general contractor as well as the delegated shoring engineer to ensure the detailing and construction of this shoring went as smoothly as possible. The final shoring strategy included needle beam shoring the masonry wall and heavy duty pole shores. The contractor elected to step up and away from the excavation instead of utilizing sheeting and shoring as the lateral loads introduced from the pole shores would have exceeded the capacity of wood lagging. The option to do any substantial sheeting and shoring was not possible due to the overhead constraints in the crawl space. In conjunction with the shoring, CVM detailed the new foundation under the existing masonry wall to be constructed in two parts, so that the first part could be installed while the shoring was in place and could then support the existing masonry wall while the rest of the elevator pit was constructed.

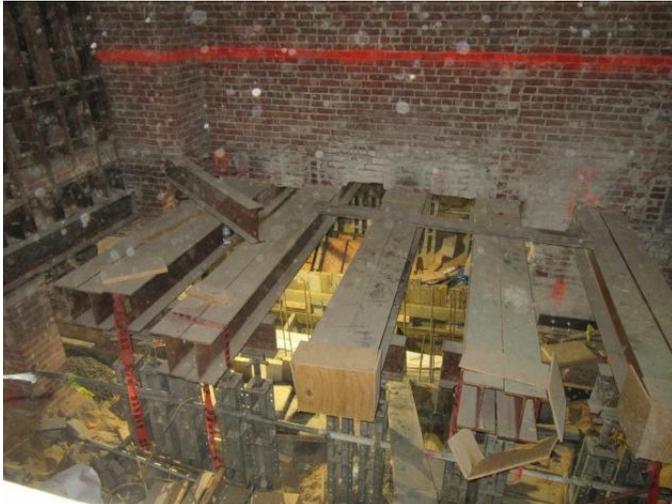
Figure 4 (Above) - Tempory needle beam shoring in place to support the interior masonry wall while the existing foundations were removed and replaced.

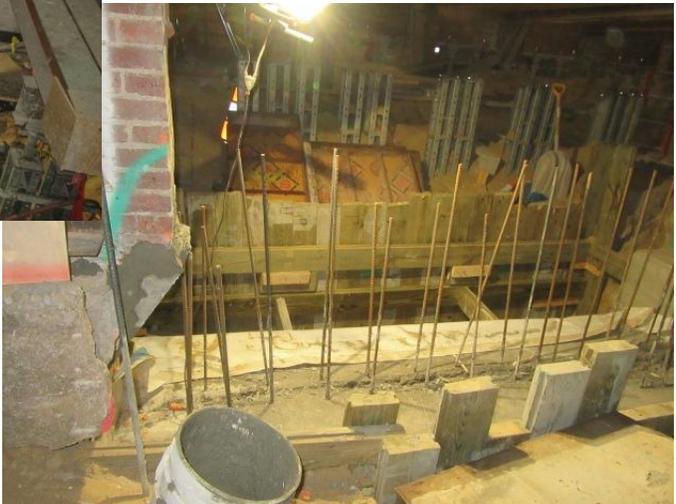
Figure 3 (Below) - Wall dowel bars sticking up from the 1st pour of concrete for the foundation under the masonry wall that supported this wall until the remaining pit was poured.

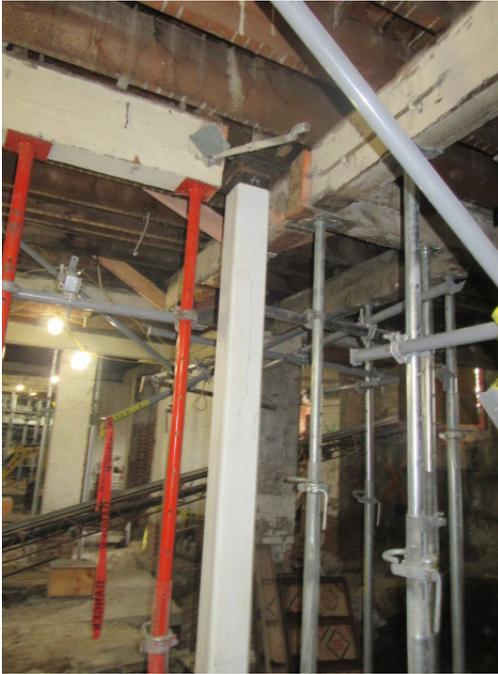
Figure 5 (Top left) - A new steel post to support new steel transfer beams with a number of shoring posts supporting the existing timber beams.

In theory, rearranging intermediate bearing walls does not sound difficult, but there was significant coordination between all disciplines of the design team to find the best placement for new steel transfer beams and posts. These not only had to work from an architectural standpoint, but also from an MEP standpoint as all of the MEP systems were completely demolished and replaced in a new configuration. The MEP coordination proved to be difficult as the historic floor to floor elevations could not be altered. In most instances, the new steel beams were installed within the depth of the floor joists with MEP running below.

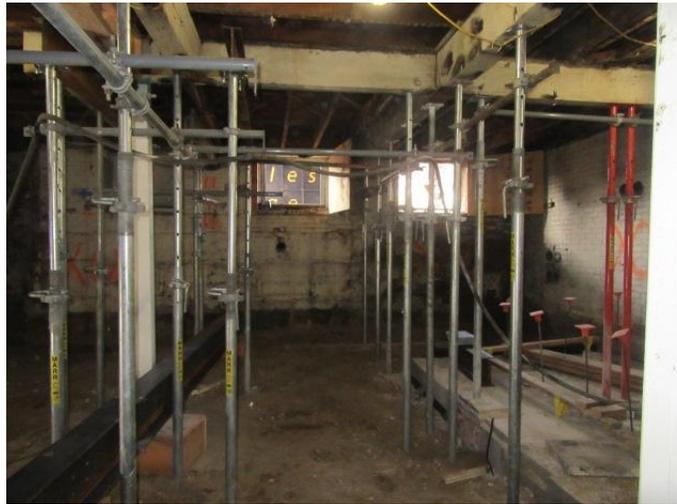
Figure 6 (Top right) - A sea of shoring posts to support both the existing timber beams that are being reconfigured and new steel beams prior to final connections.

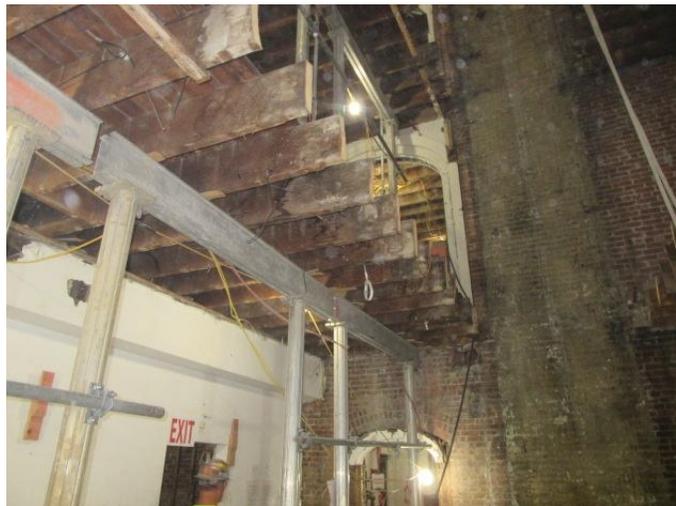
Figure 7 (Middle right) - Upper level shoring shown on multiple floors for a stacked open. This shoring extended to grade.

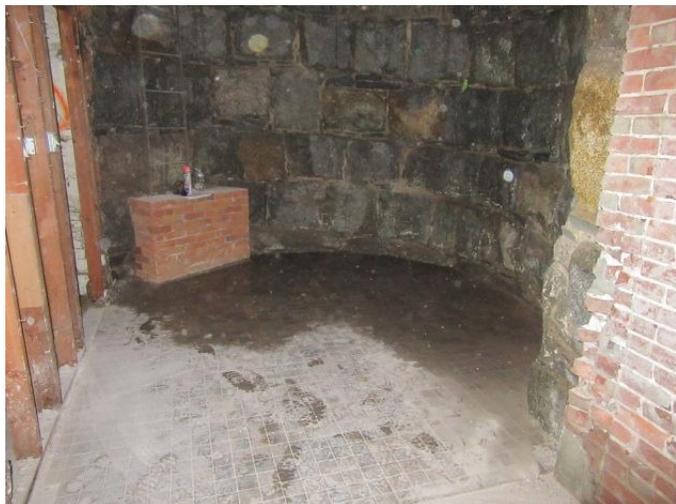
Figure 8 - (Bottom right) - A future study nook showing the water infiltration prior to waterproofing which was installed on the exterior side of the wall. See finished space in Figure 11.

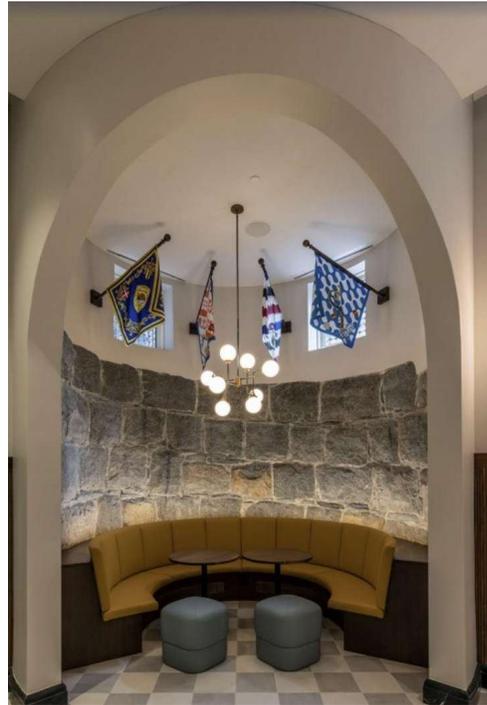
Figure 11 (Bottom Right) - Inside one of the study nooks that shows the granite block foundations. This was completely waterproofed from the exterior to keep the interior space dry.

In addition to the exterior mass masonry walls, there are two interior masonry walls that historically acted as fire separation between the different areas of the building. All of the masonry walls are supported on massive granite block foundations. Since granite is a naturally sourced material, each block is a different shape and extends past the face of the brick masonry differently. This made constructing one of new elevator pits tricky due to its close proximity to one of the interior masonry walls.

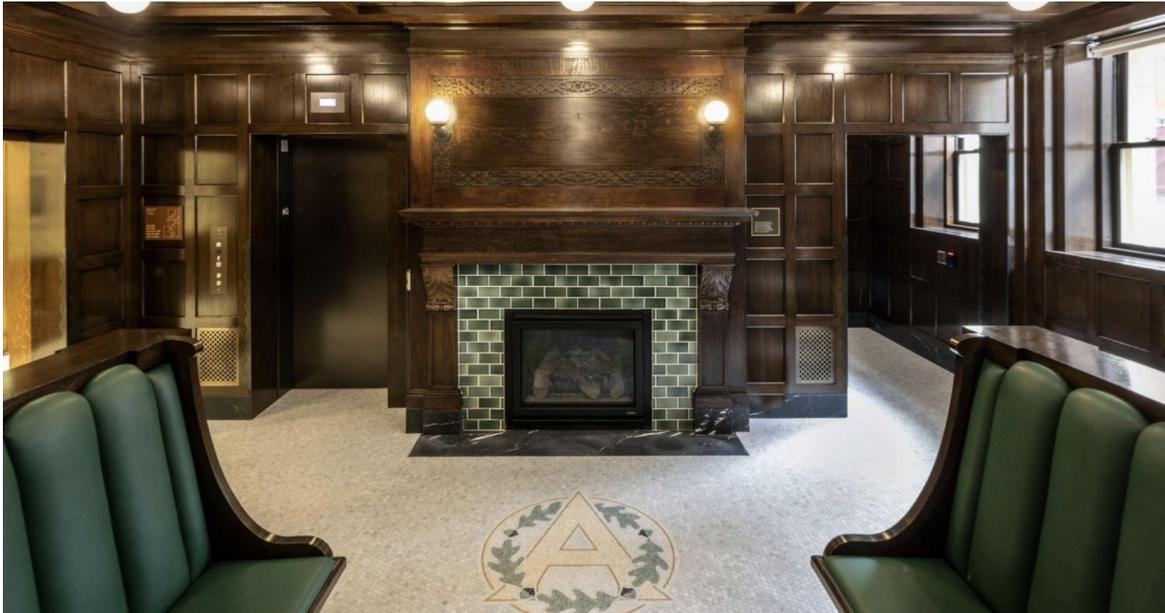
Figure 12 - Elevator lobby at the elevator where the significant shoring took place to remove the existing foundations.

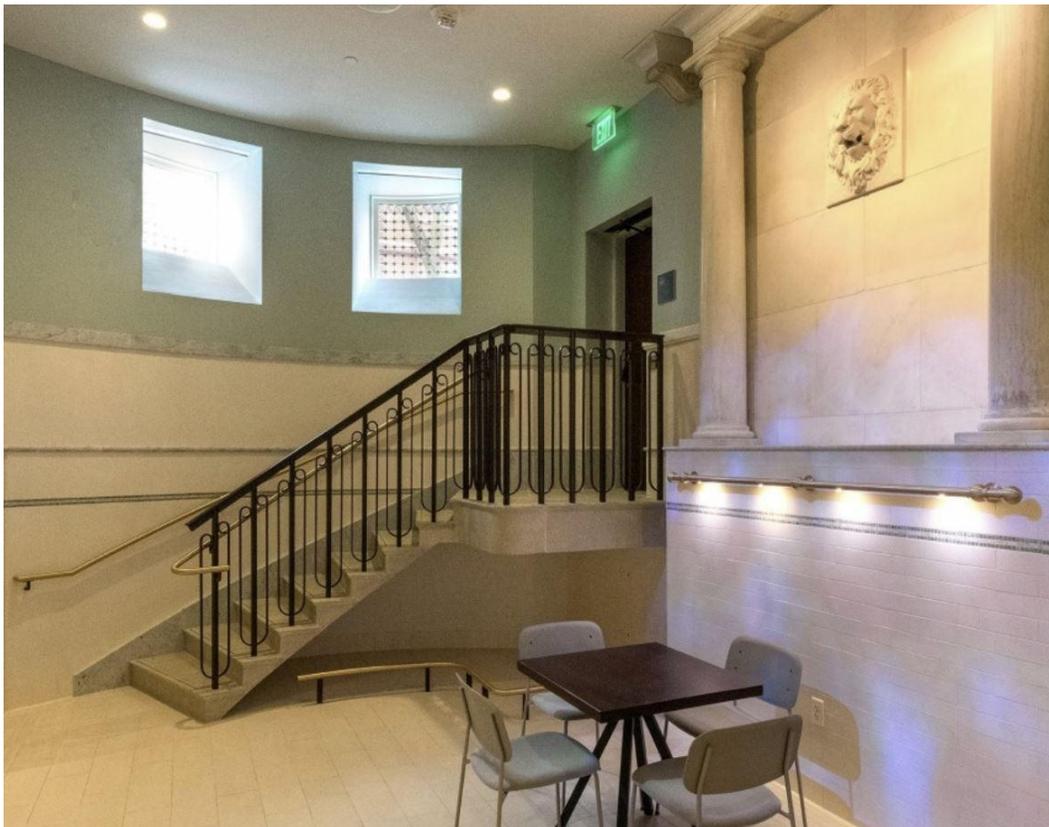
Figure 13 - A curved, cantilevered, precast concrete stair that was designed by CVM that leads into a new study area for students. This stair is mimicked from stone cantilevered stairs that have been constructed since the 1600's.
