DVASE 2021 Excellence in Structural Engineering Awards Program

Approximate construction cost of facility submitted:	\$15 MILLION
Name of Project:	Warner Hall Renovation - University of Delaware
Location of Project:	Newark, Delaware
Date construction was completed (M/Y):	Under Construction
Structural Design Firm:	Thornton Tomasetti
Affiliation:	All entries must be submitted by DVASE member firms or members.
Architect:	ABHA Architects in collaboration with Robert A.M. Stern Architects
General Contractor:	Whiting-Turner

Thornton Tomasetti provided structural engineering services for the renovation of Warner Hall, a three-story building composed of wood, steel, and brick masonry wall structures. Warner Hall was originally constructed in 1914, and has served as a women's residence hall for the University of Delaware prior to this renovation which will convert the building into the central hub for Wellness and Counseling. The floors of the hall are a mix of wood and steel elements, and the roof contains heavy timber and 2x wood. The intent of the project is to preserve as much of the original facade and structure as possible while converting the building's interior spaces.

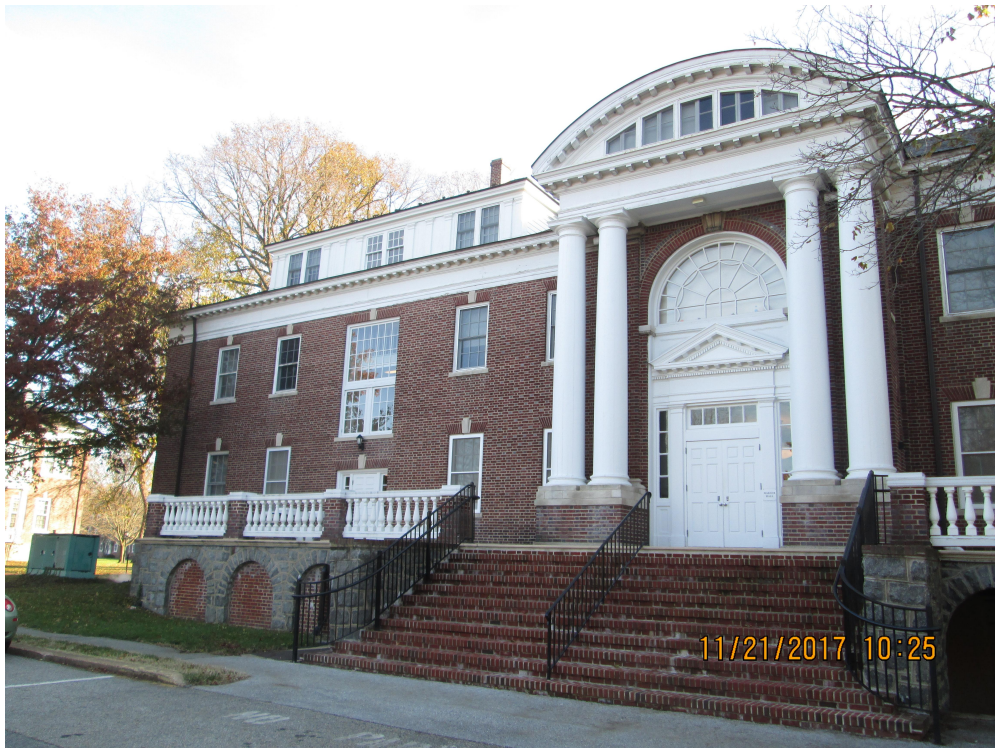
Warner Hall - University of Delaware during initial condition assessment.

The project team was tasked with an initial condition assessment of the structural and exterior elements. As an operating dormitory, efforts continued through construction when access became more available. Major repairs included the rehabilitation of the west patio with an entire replacement of the slab and cover-plating of the corroded steel beams, as well as damaged joist repairs found during demolition.

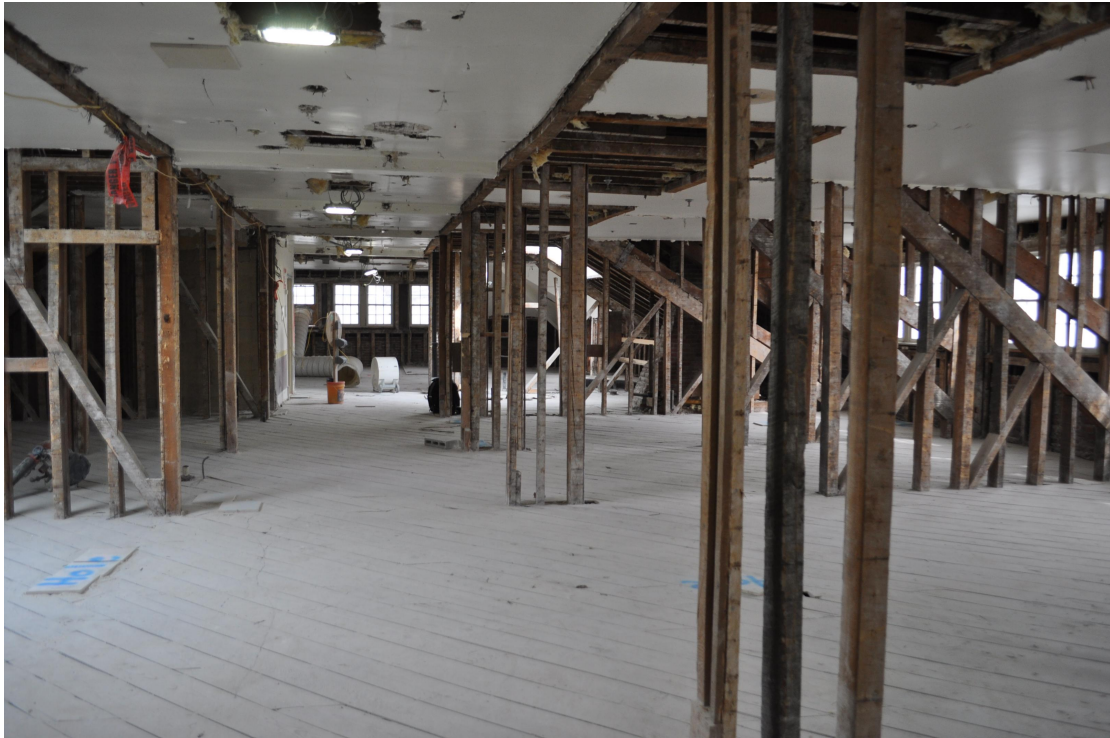
Interior framing at Level 3 after demolition

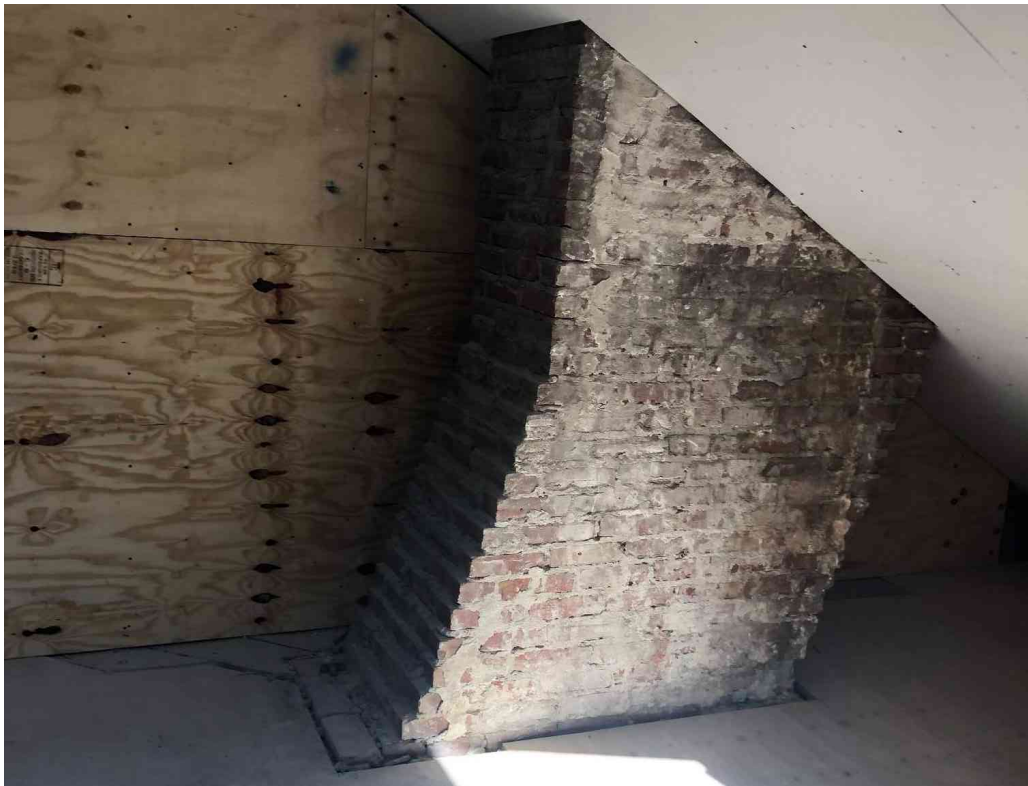
Corbeled chimney in the attic

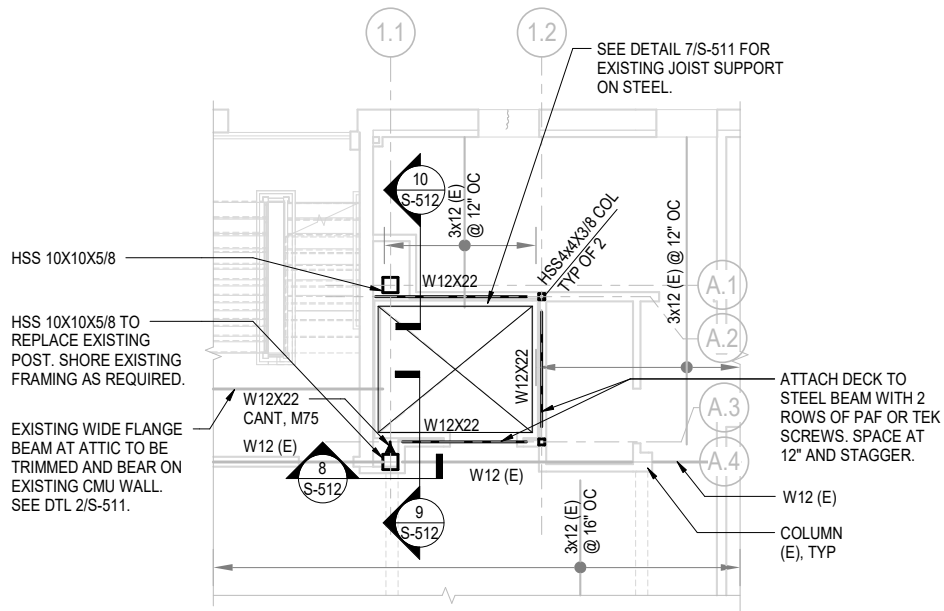
2 PARTIAL FIRST-ATTIC LEVEL FRAMING PLAN

Partial plan of new elevator shaft at typical floors

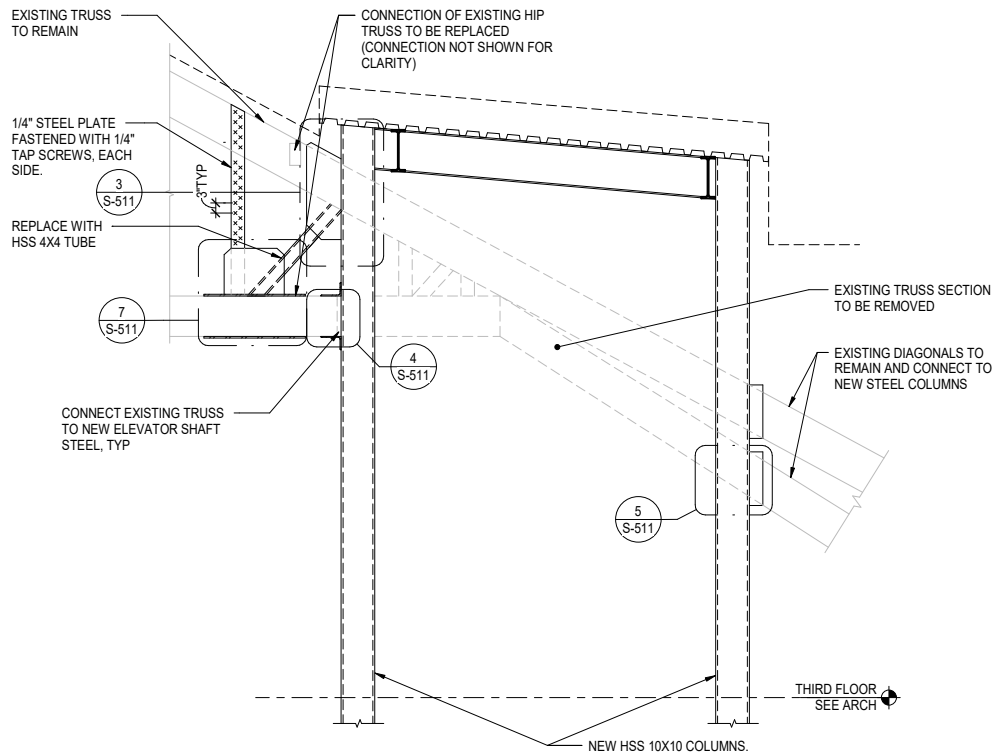
1 EXISTING TRUSS SUPPORT AT ELEVATOR SHAFT

Elevation of roof truss modifications at elevator shaft

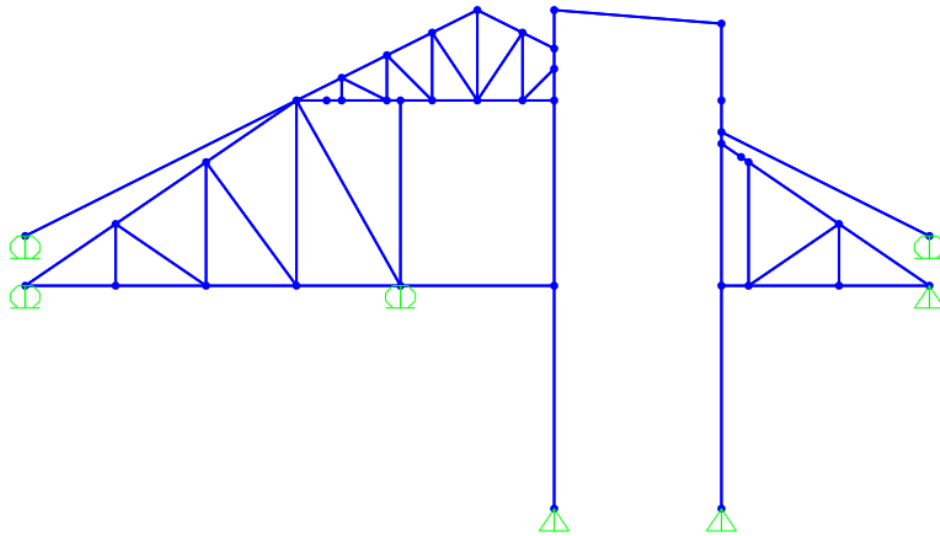
Roof truss modifications at elevator shaft - SAP analysis model

Multiple analyses were performed on the truss, with different combinations of boundary conditions at the supports to quantify the change in behavior under both gravity and lateral loads. Where other members of the truss were overstressed, reinforcing was provided. For smaller overstresses, steel plates were fastened with screws to existing wood members to increase axial capacity. Some members and connections experienced larger overstresses that required web members to be replaced with HSS 4x4 tubes and steel-to-wood connections. Close attention was paid to avoid disturbing the hip truss connections, where possible. Since the attic is tightly spaced wood framing that is over a hundred years old, field welds on new steel were avoided for safety reasons.

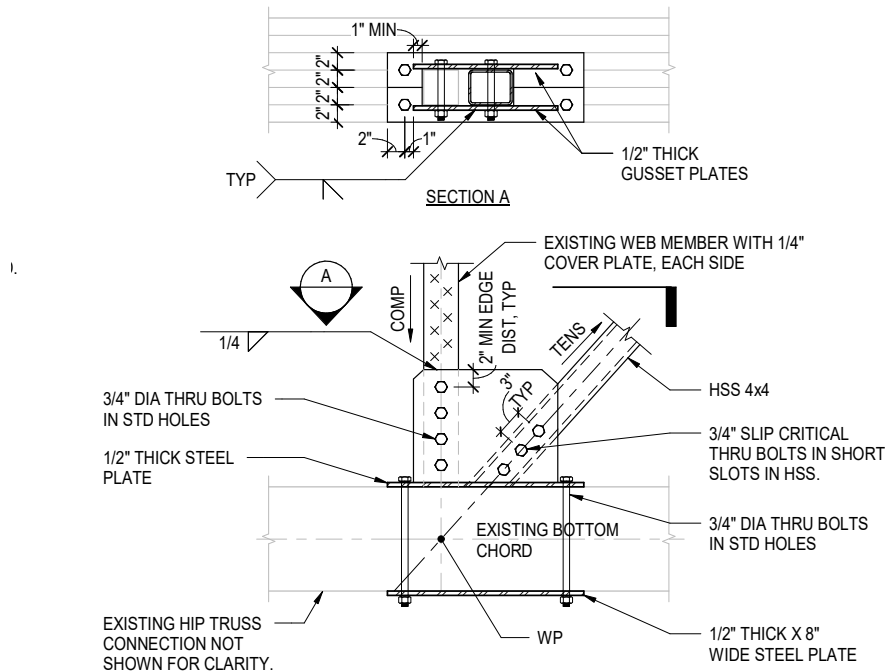
LOWER WEB CONNECTION

Roof truss modifications at elevator shaft - sample connection repair detail
